INSPECTION CONDITIONS

DATE OF INSPECTION: May 15, 2009.
TIME OF INSPECTION: Started at - 3:00 p.m. Inspection concluded at approximately - 6:00 p.m.
CLIENT NAME: Jane Doe.
INSPECTION LOCATION:

204 Main St.

INSPECTION CITY/STATE/ZIP: Small Town USA.

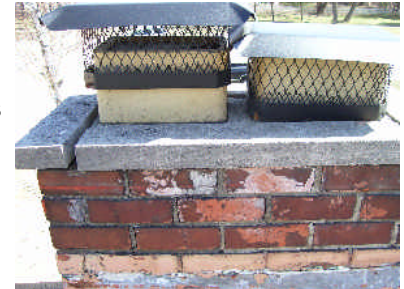
MATERIAL 1: Brick. Services; Heating system, Water heater, Fireplace.
CONDITION 1: Chimney crown maintenance needed. Crown noted for loose mortar/cracks, ect. Repairs as needed. Comment: Chimneys often need maintenance work or repair, most commonly is the crown at the top of the chimney in need of some sort of maintenance or repair. Mortar between bricks can loosen or damage to the brick face can occur, this condition is called spalling. In time water seepage into the brick itself, combined with weather conditions over an extended period can result in this type of damage. The key is periodic maintenance and inspections on the chimney itself. Chimney sweeps are the preferred maintenance and repair contractors that specialize in this type of work. Oftentimes names of these people can be obtained from a chimney sweep or a fireplace accessory shop.

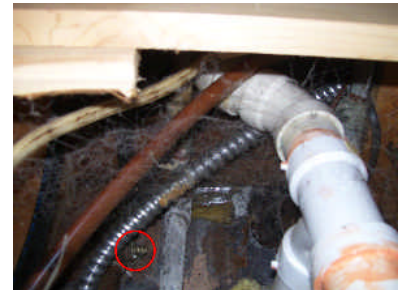
Meter is location on - Exterior. Meter appears serviceable. Lines corrosion proofed where visible. Noted: service line is not properly capped off with a plug behind laundry wall access panel, THIS IS A SAFETY HAZARD!

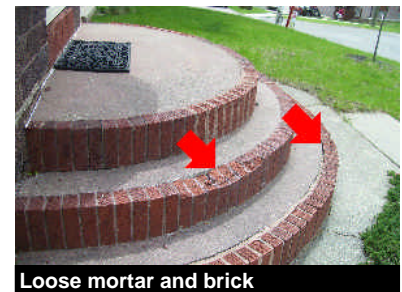
TYPE & CONDITION: Porch slab concrete. Appears serviceable.
STEP / RAILS: Step(s) are concrete & brick. Deterioration to the brick / mortar. **THIS MAY POSE A TRIPPING HAZARD!** A qualified masonry contractor evaluate conditions and make repairs as needed.
