ROOF SYSTEM

ATTIC:

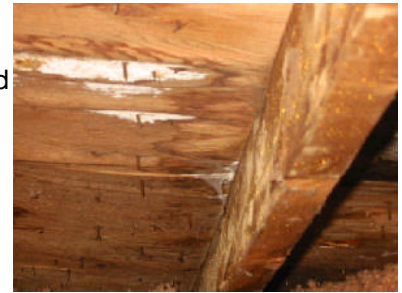
Signs of past stains / leakage. Active leakage may be present. A licensed roofing contractor should be called to make further evaluation and repairs as needed.
